# STUDY OF THE LICHENS OF THE MEHDIA' KASBAH, HISTORICAL MONUMENT OF KENITRA, MOROCCO

The aim of this study is to inventory and describe the lichenic flora that colonizes the Kasbah walls of Mehdia (Ksar Moulay Ismail), a historical monument in Kenitra. The Kasbah of Mehdia had an aesthetic and architectural value and has suffered over time various alterations. Building materials around the world are exposed to various degradation factors and alteration caused by the climate, living things (biological) and time. The alterations of the monuments can be grouped into three main categories: physical, chemical and biological. The lichen species encountered are *Dirina ceratoniae* Mont., (1849), *Dirinamassiliensis* f. *massiliensis* Durieu & Mont., (1848), *Roccellaphycopsis* (Ach.) Ach., (1810) and *Verrucaria minor* Breuss, (2007). These species can cause with other environmental factors the deterioration of building materials of the Kasbah. Lichens can be the cause of modifications of the surfaces of the stones of the monuments by the bio geophysical and bio geochemical processes. Bio-geophysical changes are caused by hyphal penetration beneath the stone surface and contraction and

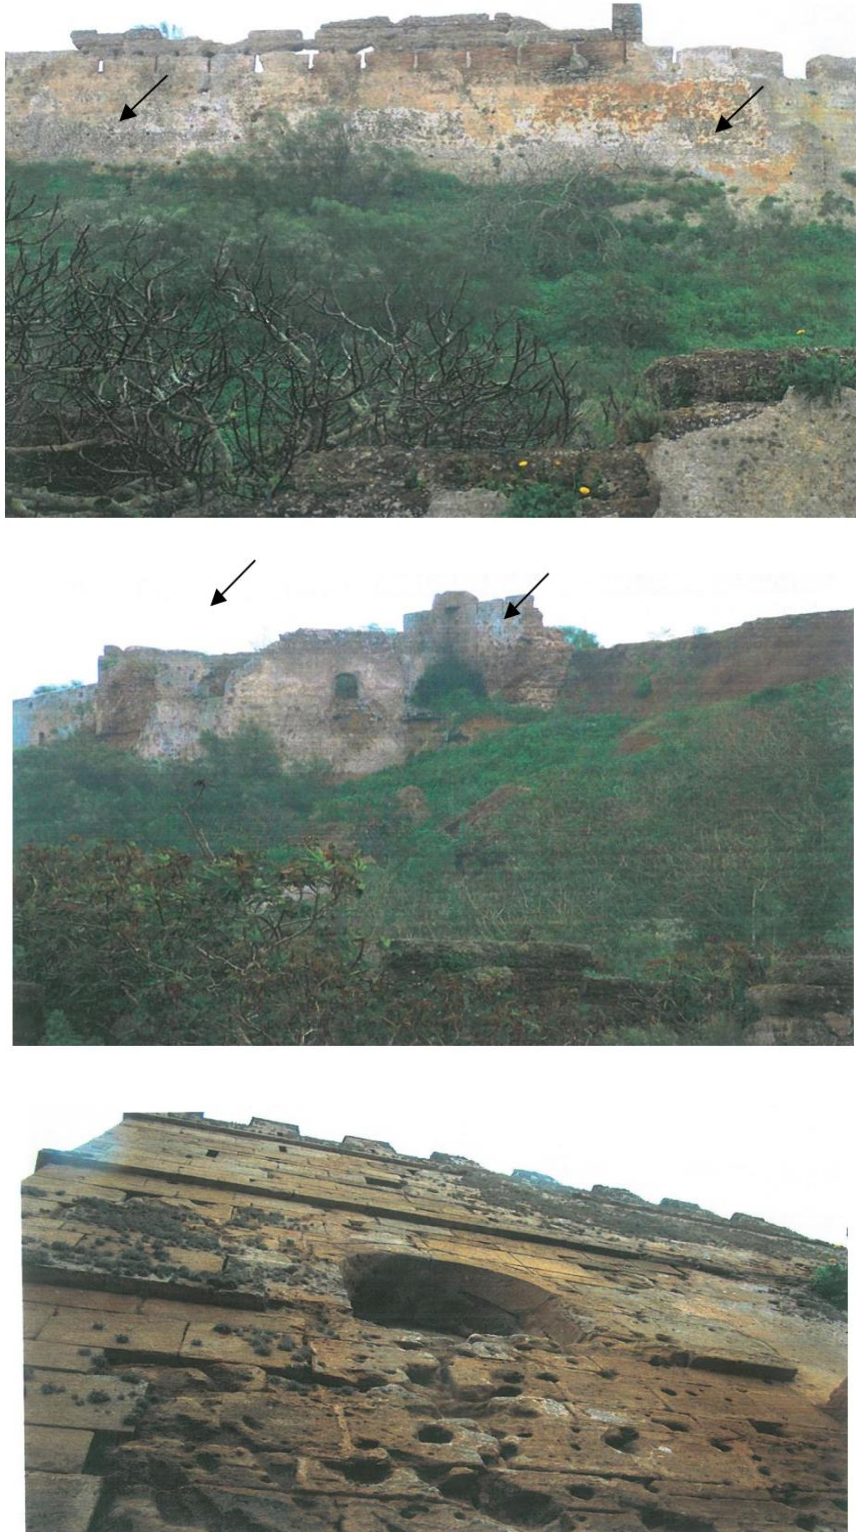
The species found in Kenitra' Kasbah (Figure 1) are *Roccella phycopsis*, *Dirina ceratoniae*, *Dirina massiliensis* f. *massiliensis* and *Verrucaria minor*.

**Figure 1: Development of lichens (L) on the walls of the Kasbah of de Mehdiya (A, B and C)**

*Roccella phycopsis* has been found in the walls of the Kasbah Gate and in areas where the substrate is exposed to the humid winds of the sea. It covers a few centimetres above ground level and, according to Liscia et al. [4], thallus are always fixed vertically to the substrate.

*Dirina ceratoniae* was noted on the walls in the center of La Kasbah. *Dirina massiliensis* morpho. *massiliensis* and *Verrucaria minor* were found in the same place, fixed on the rest of the rocks inside the kasbah. Giacobini [5], reported *Dirina massiliensis* on the marble portal of Orvieto Cathedral where it causes corrosion. Seaward and Giacobini [5] confirmed the corrosive effect of this species on *Caprarola farnesis* frescoes. It has also been observed on granite, trachyte, and basalt northwest of Sardinia [4].

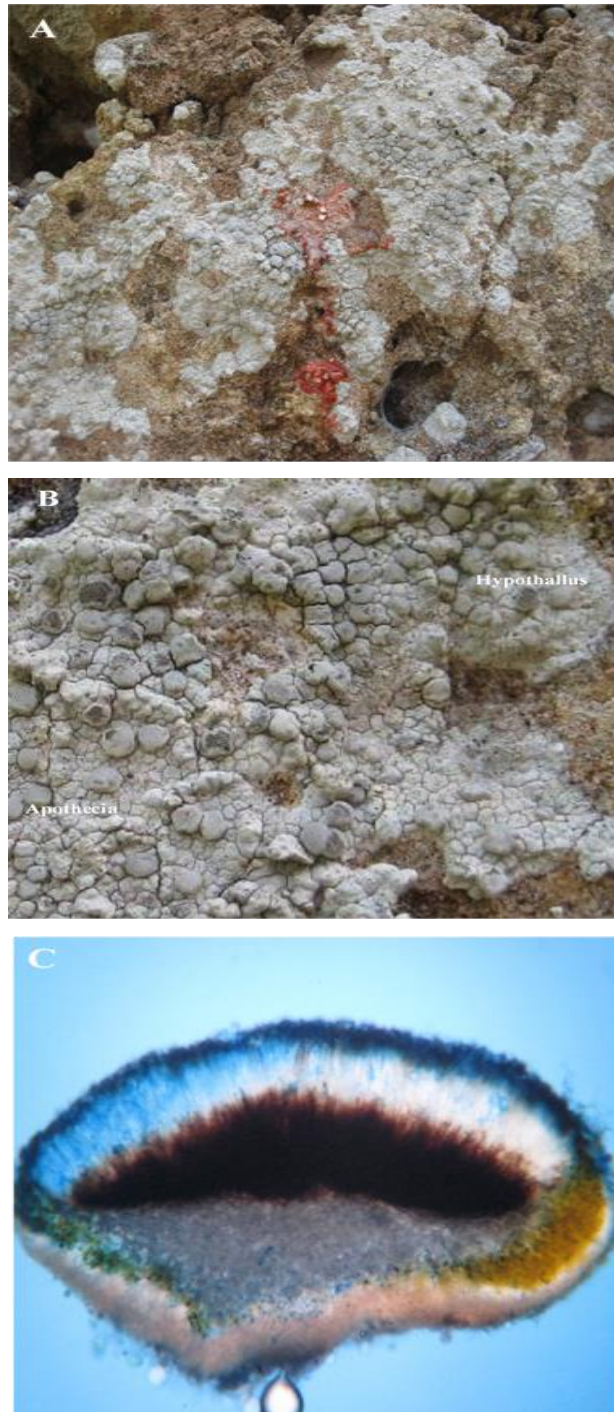
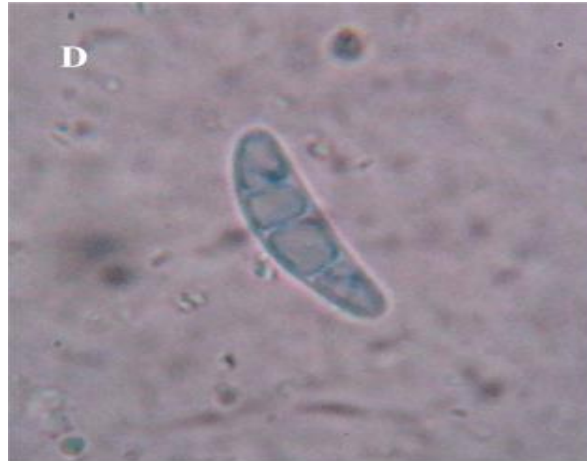
This species was collected on 20/04/2013 on a limestone rock. The thallus, 4 cm in diameter, is crustacean, whitish-gray in color, with a smooth, thick, solared surface. It is limited by a whitish gray hypothalle (Figure 2 B). The thallus becomes red under the effect of sodium hypochlorite (Figure 2A). Apothecia, 1 to 1.8 mm in diameter, are whitish gray, the margin is thallus-like, the disc is covered with whitish-gray pruinias. The hypothecium is black (Figure 2 C). The asci, 24 x 4  $\mu\text{m}$ , contain 8 ascospores, elliptic and hyaline (Figure 2 D).

**Figure 2: *Dirina ceratoniae*: Effect of sodium hypochlorite on thallus (A), Apothecia (B), cut of apothecia (C) and spore (D).**

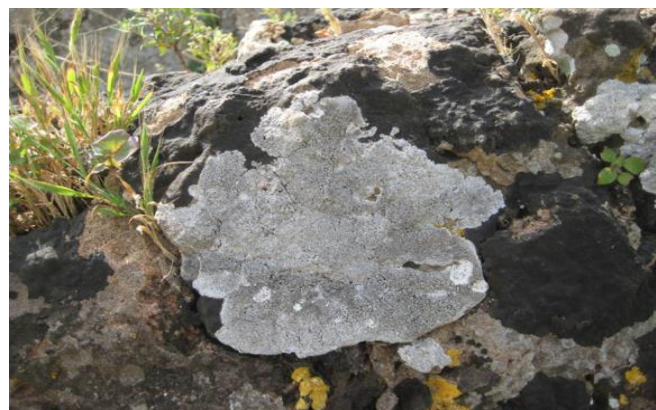
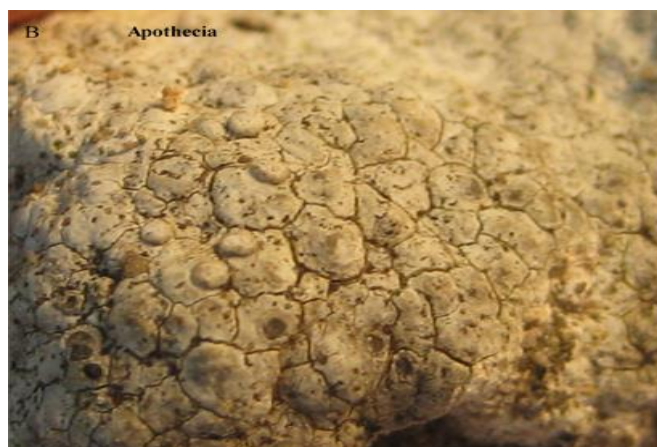
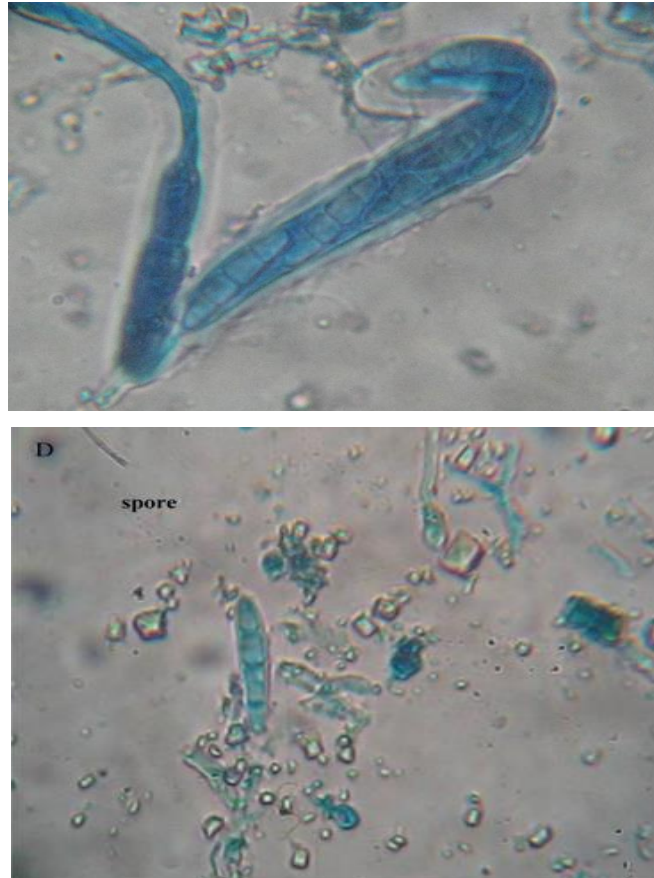
This species was collected on 20/04/2013 on a limestone rock. The thallus is crustacean, measuring 2.5 cm in diameter, smooth, whitish-gray (Figure 3 A). The thallus does not react with sodium hypochlorite. Apothecia, 0.5 to 0.8 mm in diameter, are whitish gray, the margin is thalid (Figure 3B), the disc is covered with whitish gray pruinias. The mortgage is black. Asci contains 8 ascospores (Figure C); elliptical hyaline and measure (22.64x 6.32  $\mu\text{m}$ ) (Figure D).

**Figure 3: *Dirina massiliensis* morpho. *massiliensis*: Thallus (A), apothecia (B), asque (C) and spore (D).**

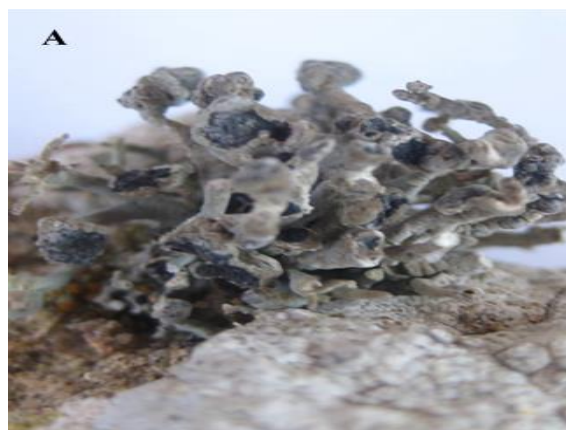
This species was harvested on 20/04/2013 on a limestone rock. The thallus is fruticulous, measuring 1 cm in length and 1.5 cm in width, of gray color, generally erect, cylindrical straps, 0.6-1 mm thick, dichotomous branches, the division being mainly towards the end (Figure 4 A); the medulla of the crampton is yellow (Figure 4 C). The thallus becomes red under the effect of sodium hypochlorite (Figure 4 B). Apothecia are terminal, measure 0.5 to 1 mm in diameter. The edge of apothecia is thallus-colored. The disc is blackish gray and covered with whitish gray pruinas. The spores (23-6.66  $\mu$ m) have 3 septa, fusiform and hyaline.

**Figure 4: *Roccella phycopsis*: Thallus with black apothecia (A), yellow spike (B), effect of sodium hypochlorite on thallus (C) and spore (D).**

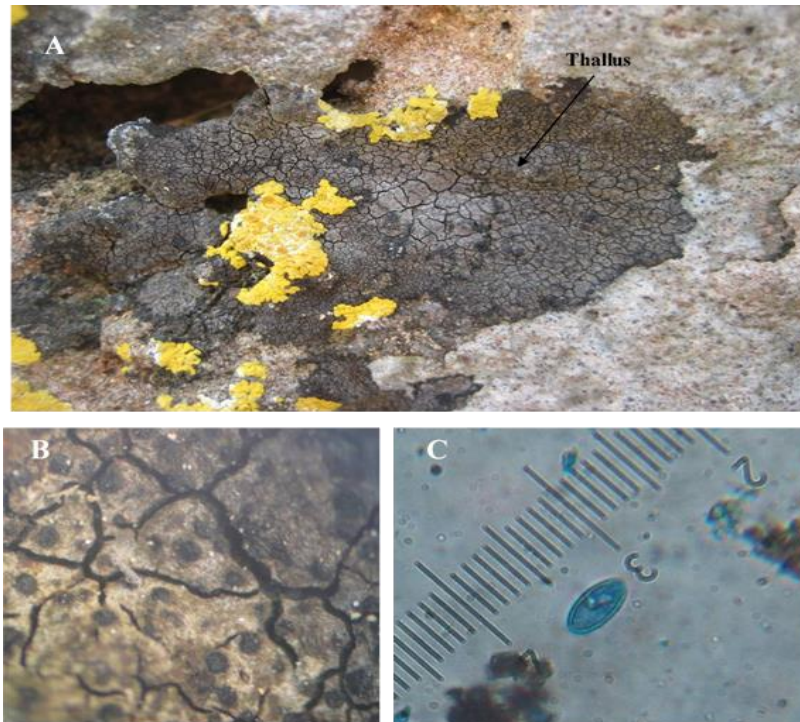
The species developed on a limestone rock, harvested on 20/04/2013, the thallus is crustacean, areolate blackish brown, matte more or less smooth (Figure 5A). Areoles flat or slightly convex. The protothalle of black color. The perithecia are semi-recessed in the thallus, black in color, solitary or grouped, measuring 0.1 to 0.2 mm in diameter (Figure 5B). The asque measures 46.62-16  $\mu\text{m}$ . Each asque contains 8 ascospores, hyaline, single (Figure 5C) and measure 17.48-7.82  $\mu\text{m}$ .

**Figure 5: *Verrucaria minor*: Thallus (A), black perithecia (B) and spore (C).**
